# Manhole Inspection Summary

Manhole # S61S\_\_005MH

Insp Date: **5/22/08 10:55 AM**

**Location** Address: **1600 S. Ponca St.**

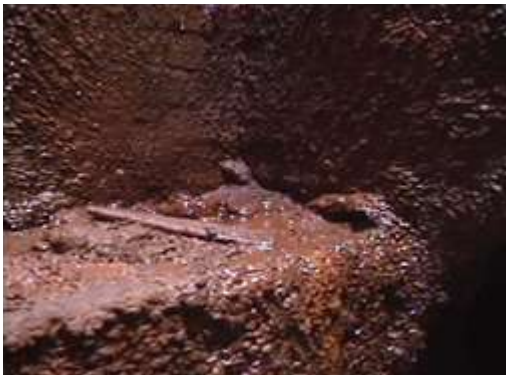
Defect 1

Condition: ☐ Sound ☐ Cracked ☐ Root Intrusion ☐ Loose Brick ☒ **Deteriorated**

Infiltration: ☐ None ☒ **Joint** ☐ Cracks ☒ **Mortar** ☐ Roots ☒ **Wall**

Infiltration at base of barrel

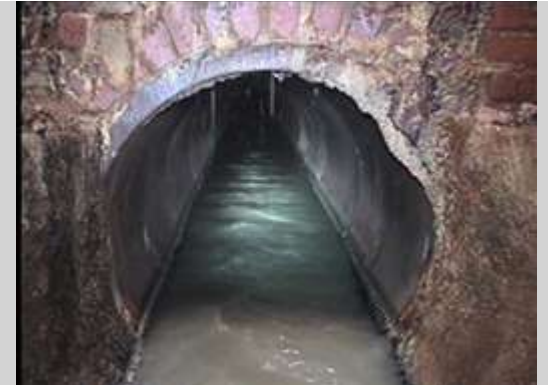
12 O'Clock Outflow

27 in. Circular Gravity Sewer  
Pipe Out @ 12 O'Clock

Pipe Height: **27.6** (in.) Rod and Bar (Angled)  
Pipe Material: **Clay** ☐ Pipe Lined  
Invert Depth: **19.33** (ft.) Flow Characteristics: **Fast**  
Deposits: ☒ None ☐ Mud ☐ Sludge ☐ Debris ☐ Grease  
Silt Depth: (in.) Deposits Extent:  
Infiltration: **None** Pipe Seal Cond: **Sound**

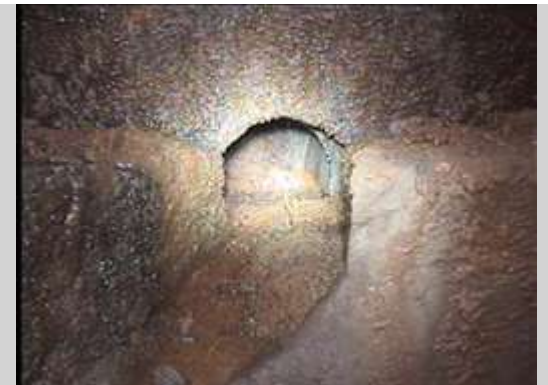
3 O'Clock Inflow

8 in. Circular Gravity Sewer  
Pipe In @ 3 O'Clock

Pipe Height: **8.4** (in.) Rod and Bar (Angled)  
Pipe Material: **Clay** ☐ Pipe Lined  
Invert Depth: **18.00** (ft.) Flow Characteristics: **None**  
Deposits: ☒ None ☐ Mud ☐ Sludge ☐ Debris ☐ Grease  
Silt Depth: (in.) Deposits Extent:  
Infiltration: **None** Pipe Seal Cond: **Sound**

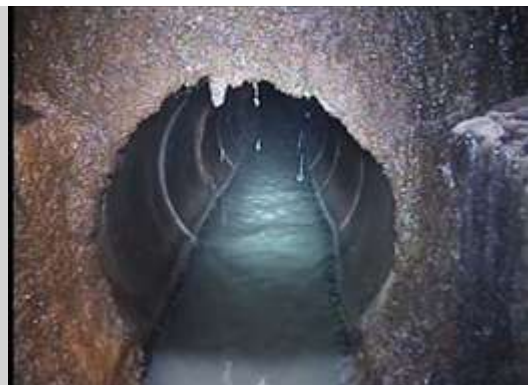
6 O'Clock Inflow

27 in. Circular Gravity Sewer  
Pipe In @ 6 O'Clock

Infiltration: **None** Pipe Seal Cond: **Sound**
